**ANACONDA SMELTER NPL SITE
COMMUNITY SOILS OPERABLE UNIT**

*West Valley Railroad Bed Investigation
Data Summary Report (DSR)*

Atlantic Richfield Company

August 15, 2003

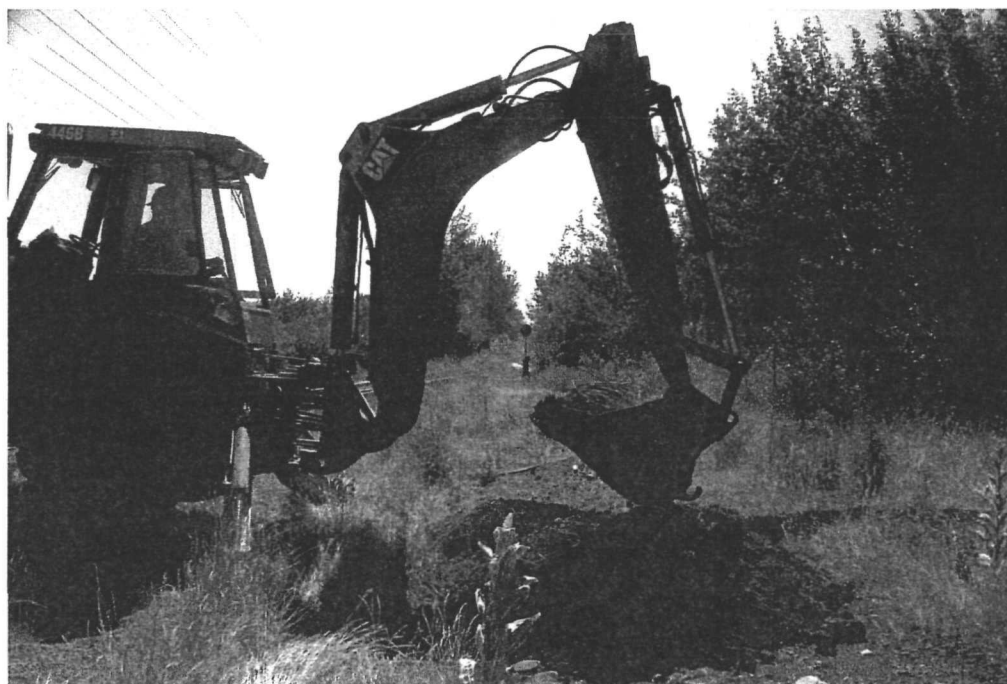
Picture #: West Valley RR Photos/Image056.jpg

Description: Test Pit by a switch – Not Sampled

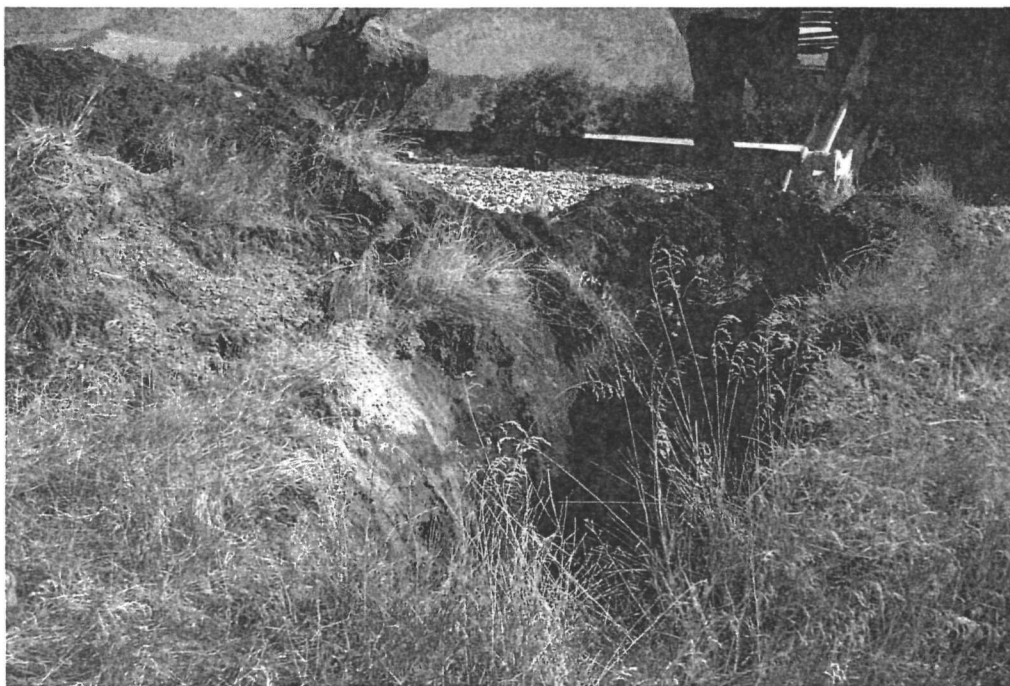
Picture #: West Valley RR Photos/Image071.jpg

Description: Trench on south side of tracks from Test Pit WVRB-60-A

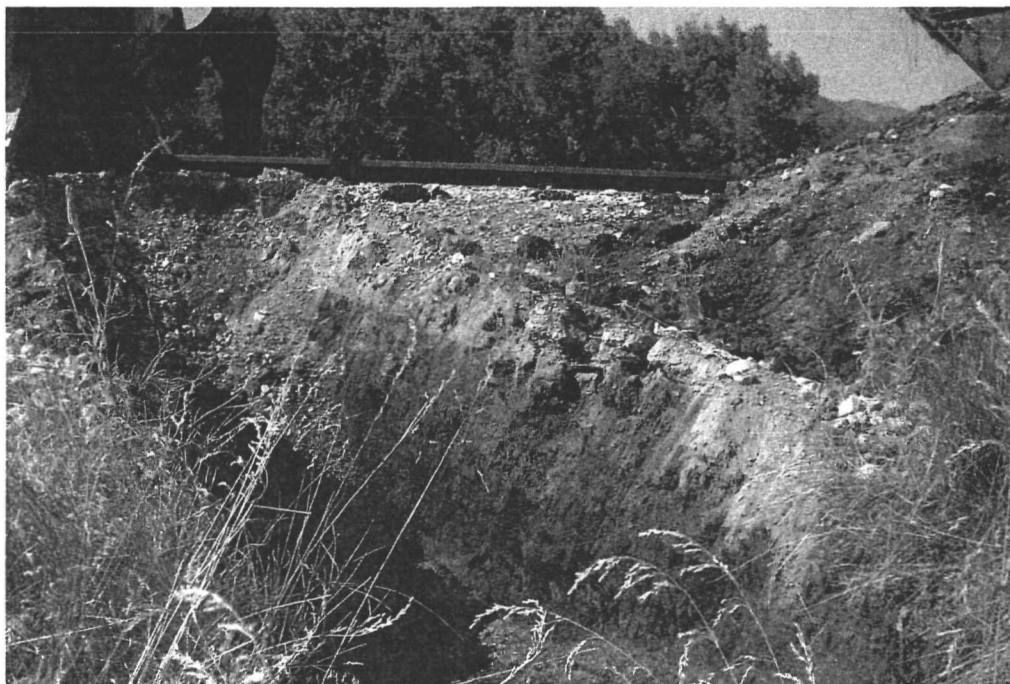
Picture #: West Valley RR Photos/Image072.jpg

Description: Trench on north side of tracks by Test Pit WVRB-60-A

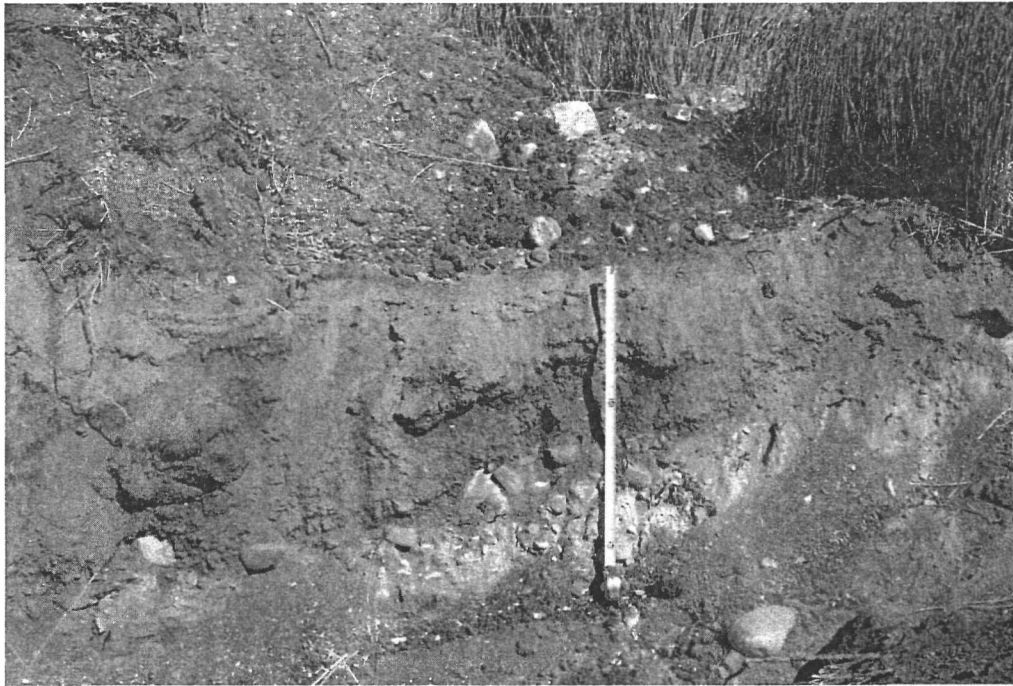
Picture #: West Valley RR Photos/Image093.jpg

Description: Trench south of Test Pit WVRB-135-A
Showing orange sand

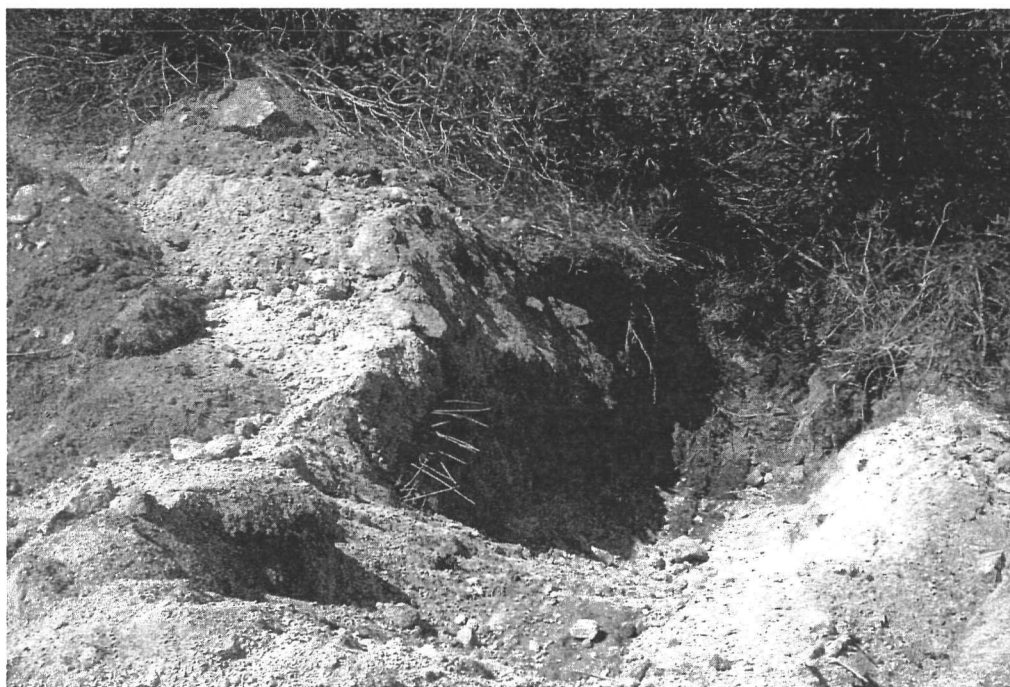
Picture #: West Valley RR Photos/Image100.jpg

Description: Trench west of Test Pit WVRB-165-A,
Opportunity Sample WVRB-165-A8
